LAWRENCE
LIVERMORE
NATIONAL
LABORATORY

LLNL-TR-648143

A Visual Description of the Concrete Exterior of the Cactus Crater Containment Structure

October 2013

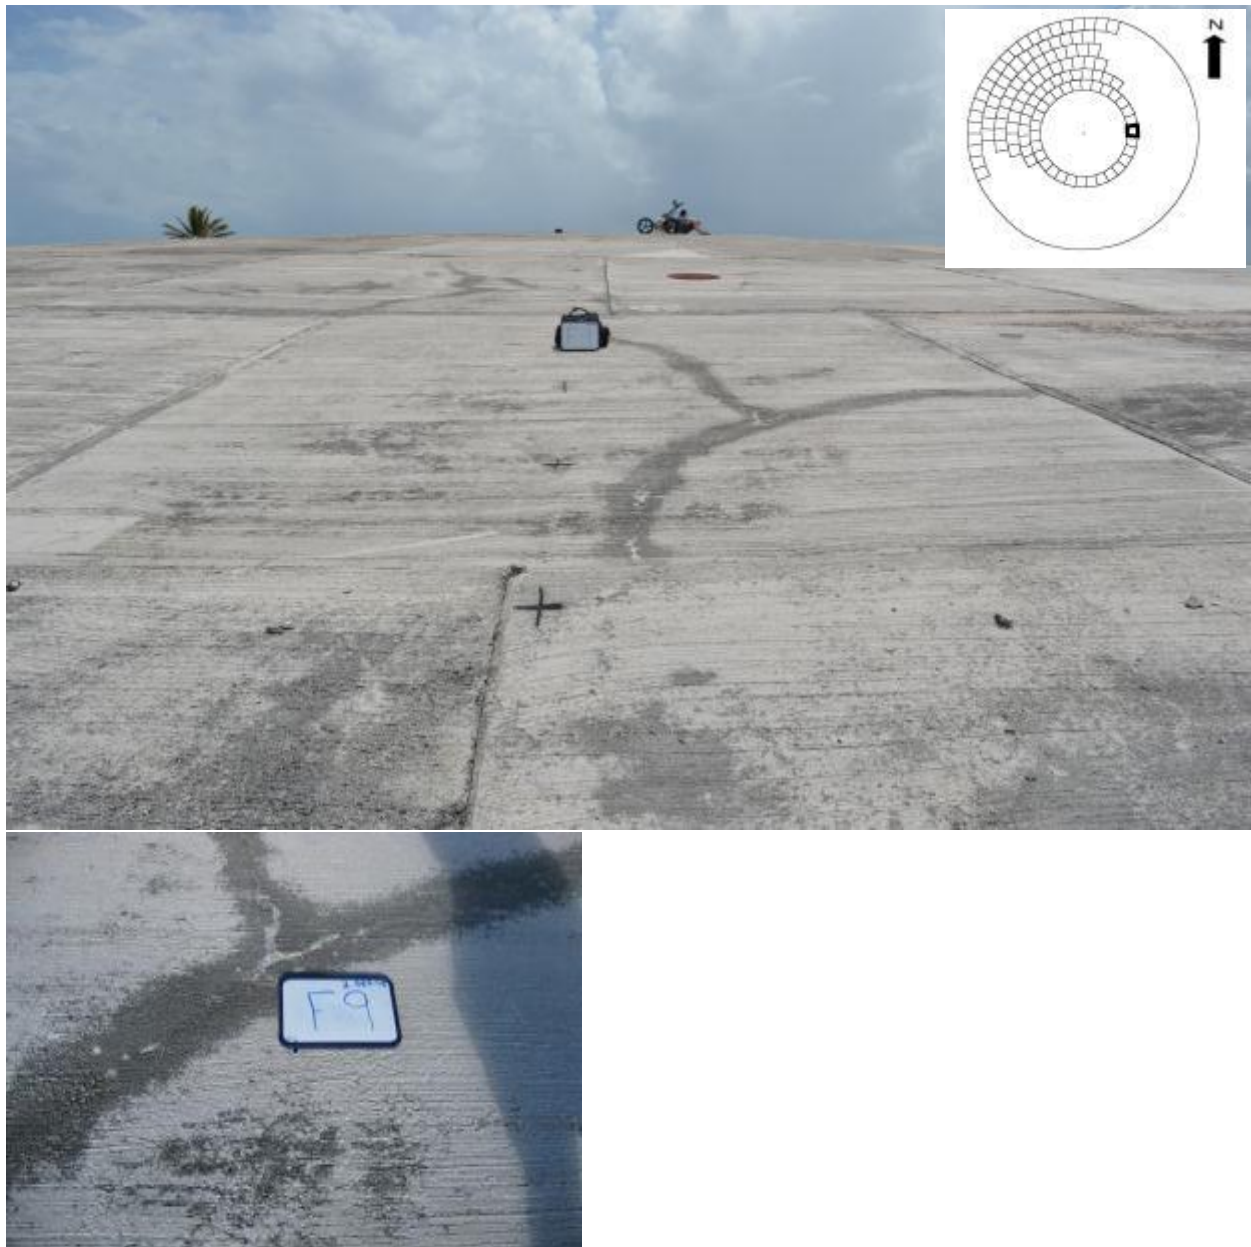
CAP SECTION LOCATION: Panel F9

Some spalling/cracking of concrete observed in the upper and lower left-hand corners of the panel. A surface crack is visible traversing up from the bottom seam from a point adjacent to the corner intersection of the E11/E12 panels on the ring row below, and traveling up the panel towards the right before branching into a fork extending upwards and out to the right side of the panel.

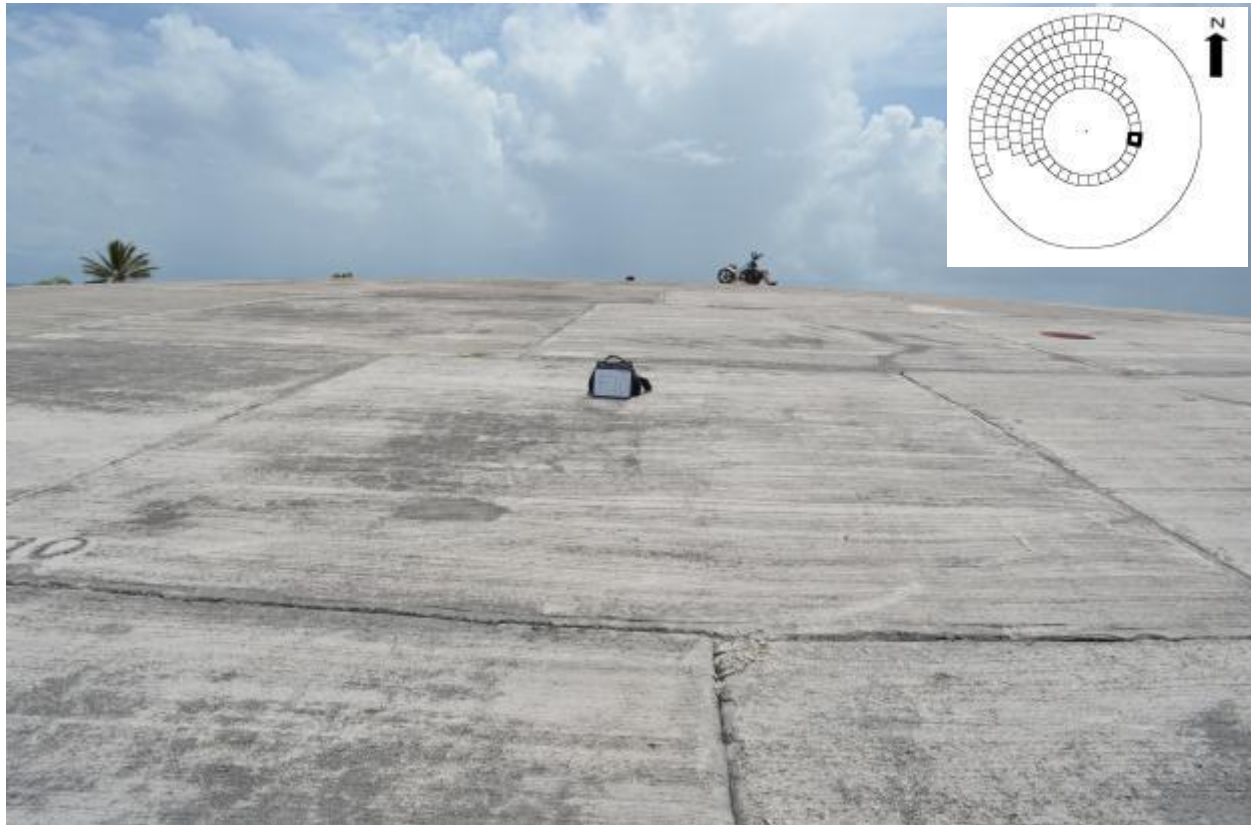
CAP SECTION LOCATION: Panel F10

No significant or obvious interior cracks or spall elements identified. Some spalling/cracking of concrete observed along the bottom seam of the panel.

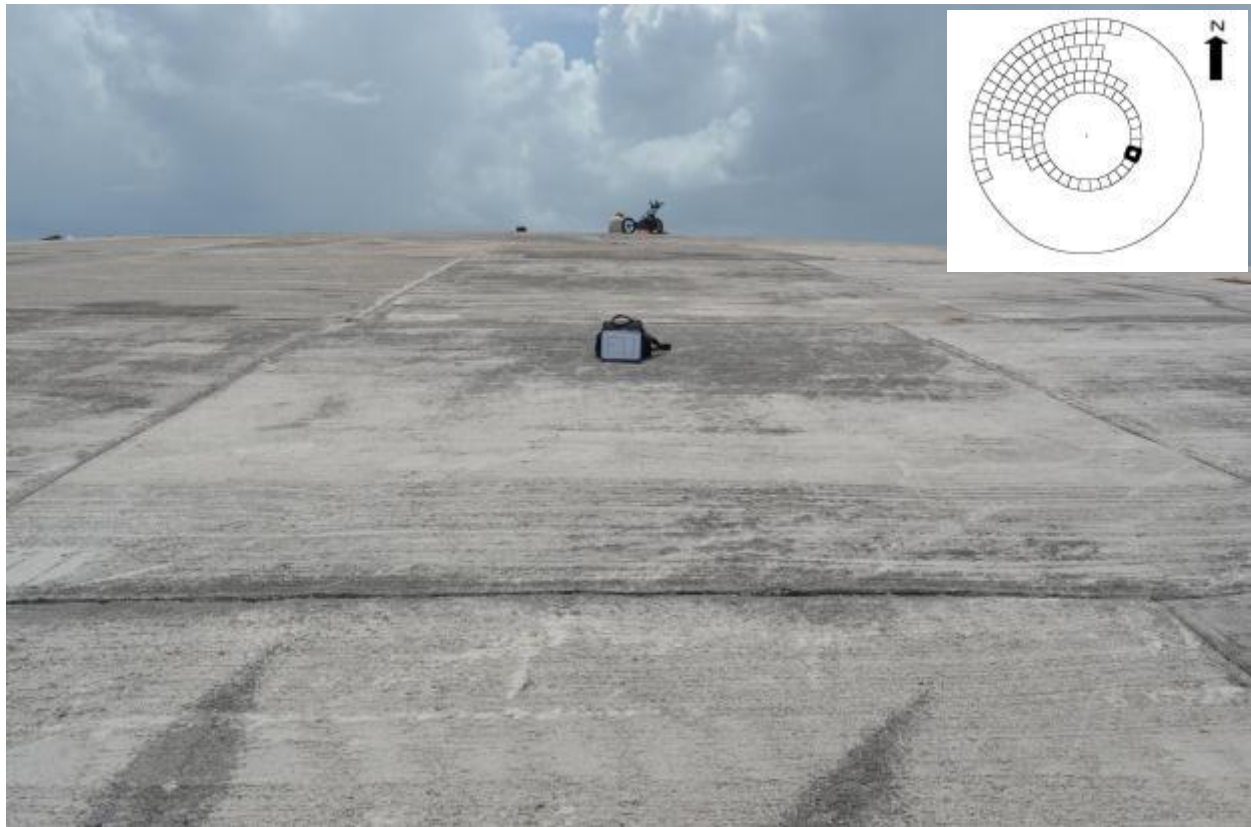
CAP SECTION LOCATION: Panel F11

The panel contains patches of discolored concrete. No significant or obvious interior cracks or spall elements identified. Rooting vegetation removed from along the panel seams.

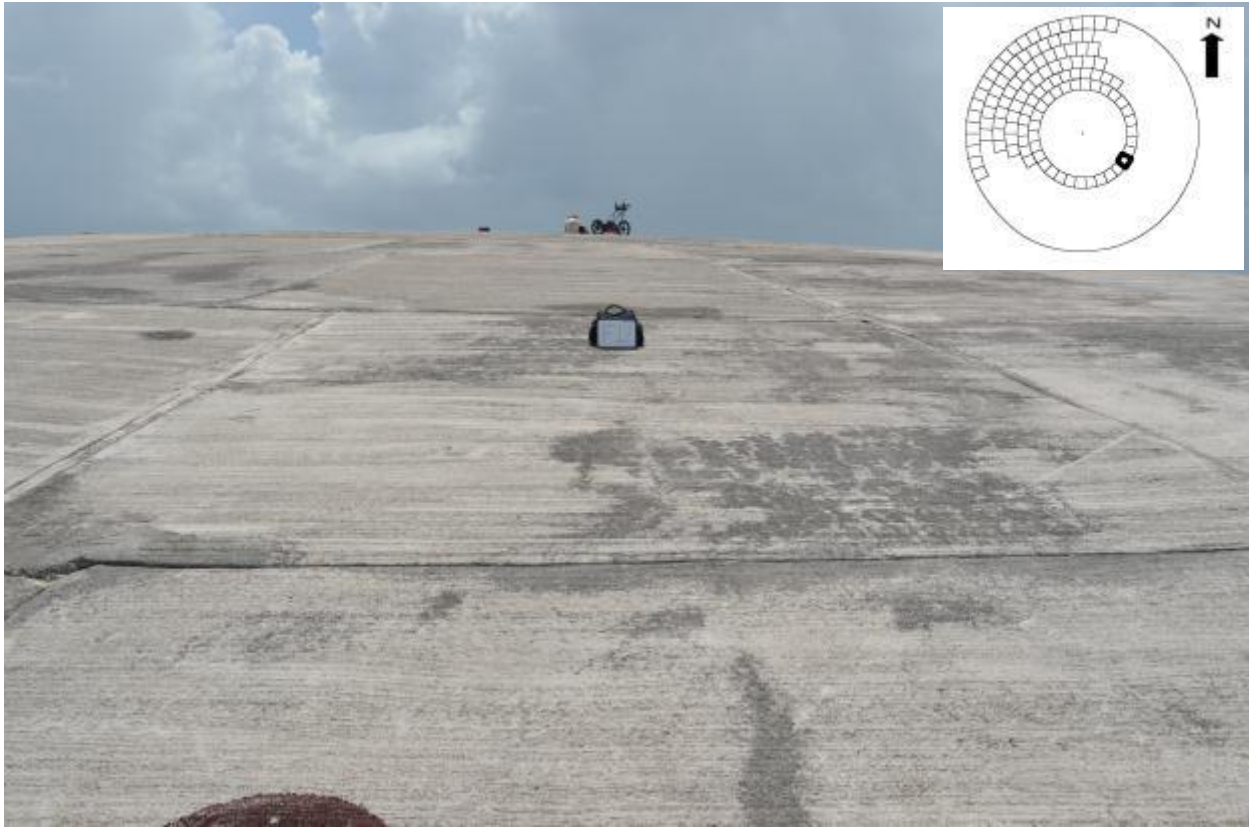
CAP SECTION LOCATION: Panel F12

The panel contains patches of discolored concrete. There is some spalling/chipping of concrete evident in the bottom left-hand corner of the panel. Also, minor spalling/chipping of concrete observed across the top seam of the panel. Rooting vegetation removed from along the panel seams. Panel contains a filled bore-hole (CD-5) from the 1980 NAS investigation.

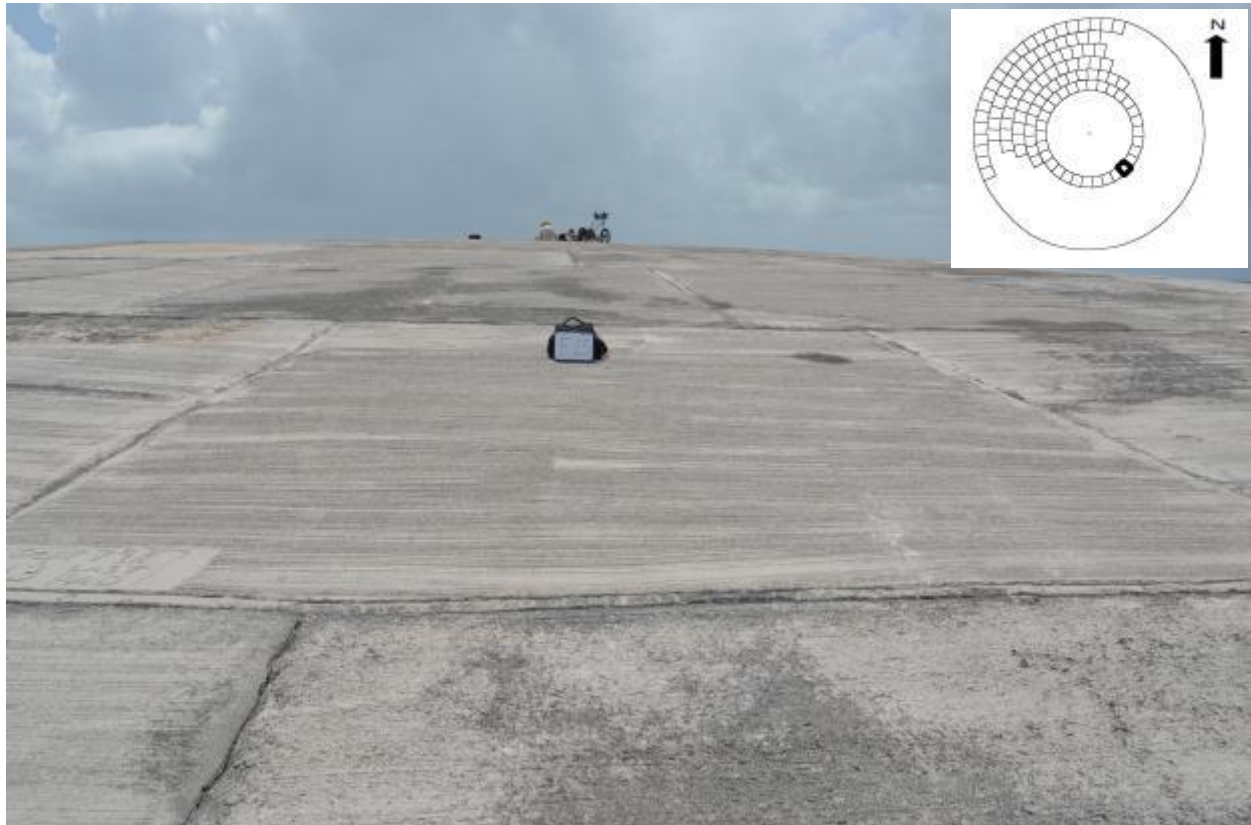
CAP SECTION LOCATION: Panel F13

No significant or obvious interior cracks or spall elements identified. Some minor spalling/chipping of concrete in the top and bottom left-hand corners of the panel.

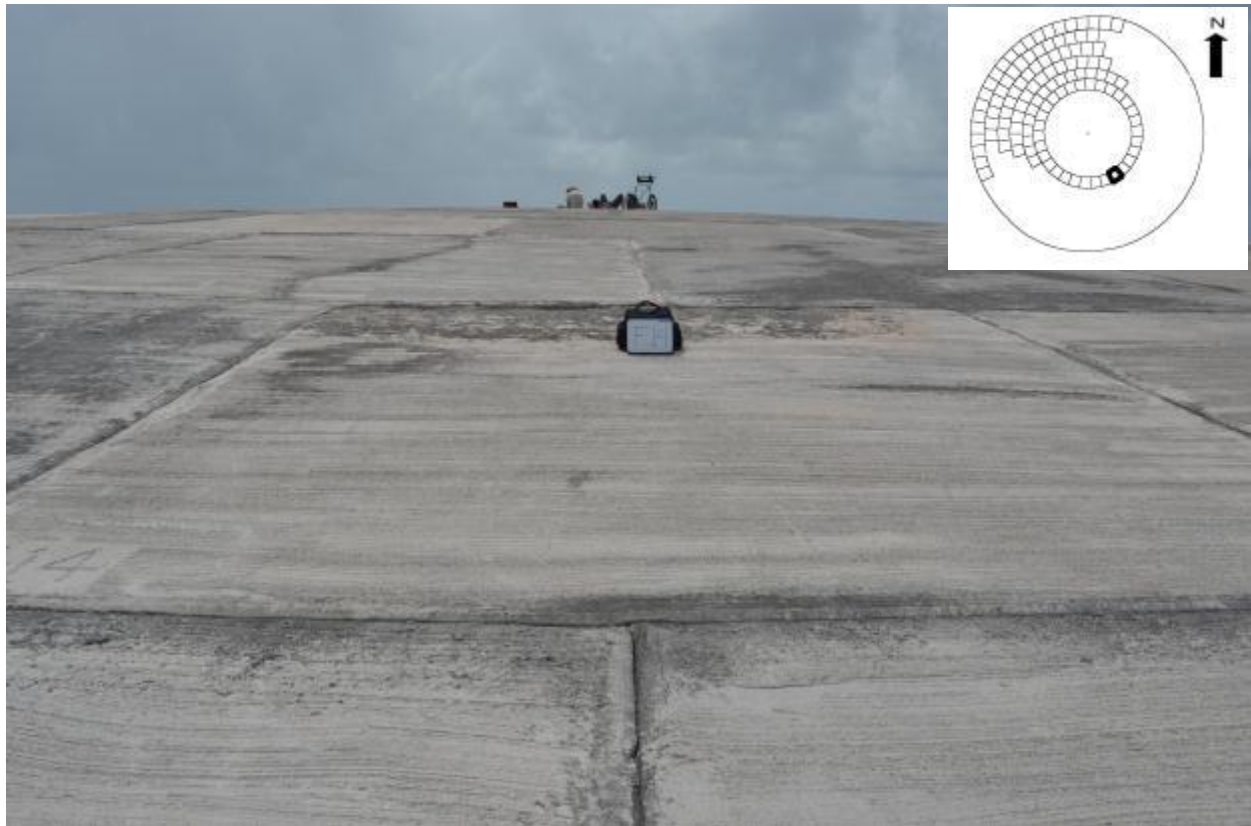
CAP SECTION LOCATION: Panel F14

Top portion of the panel has a rough and weathered appearance. No significant or obvious interior cracks or spall elements identified.

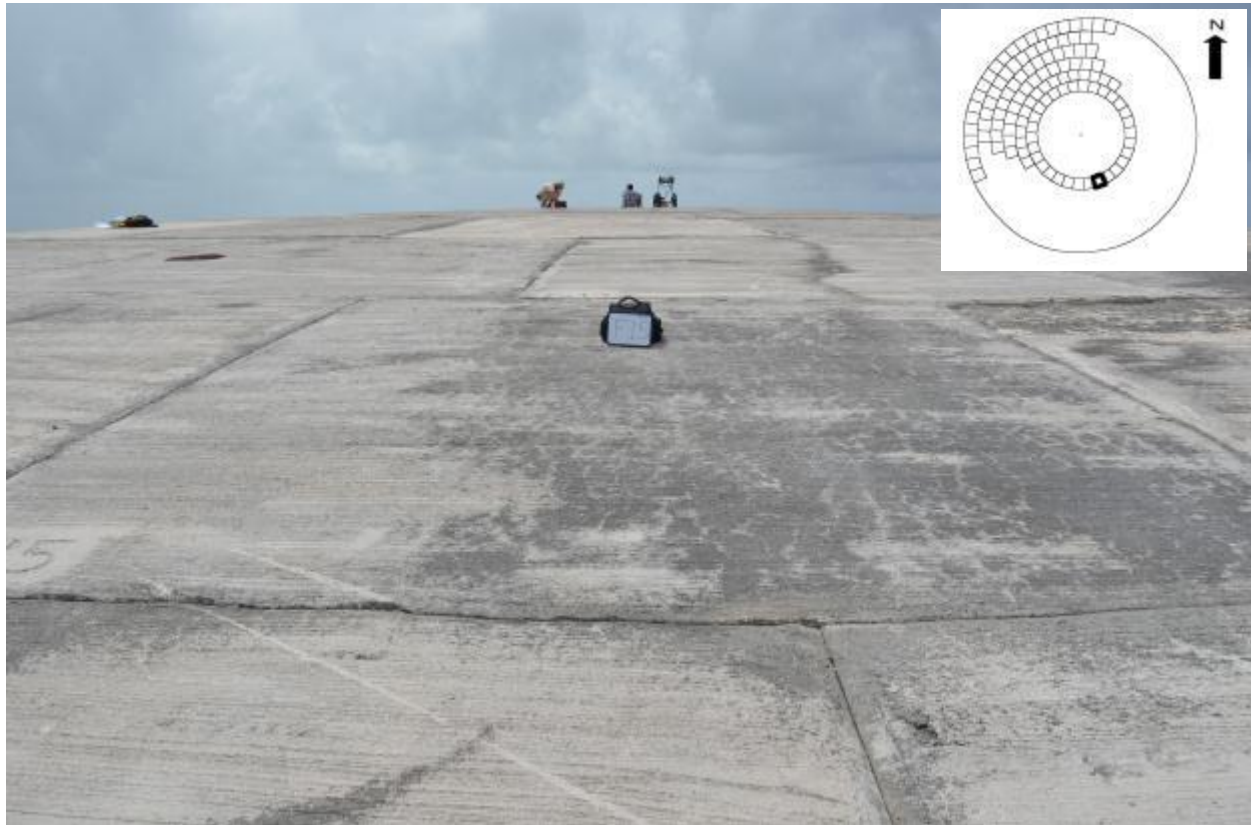
CAP SECTION LOCATION: Panel F15

The panel contains patches of discolored concrete. No significant or obvious interior cracks or spall elements identified.

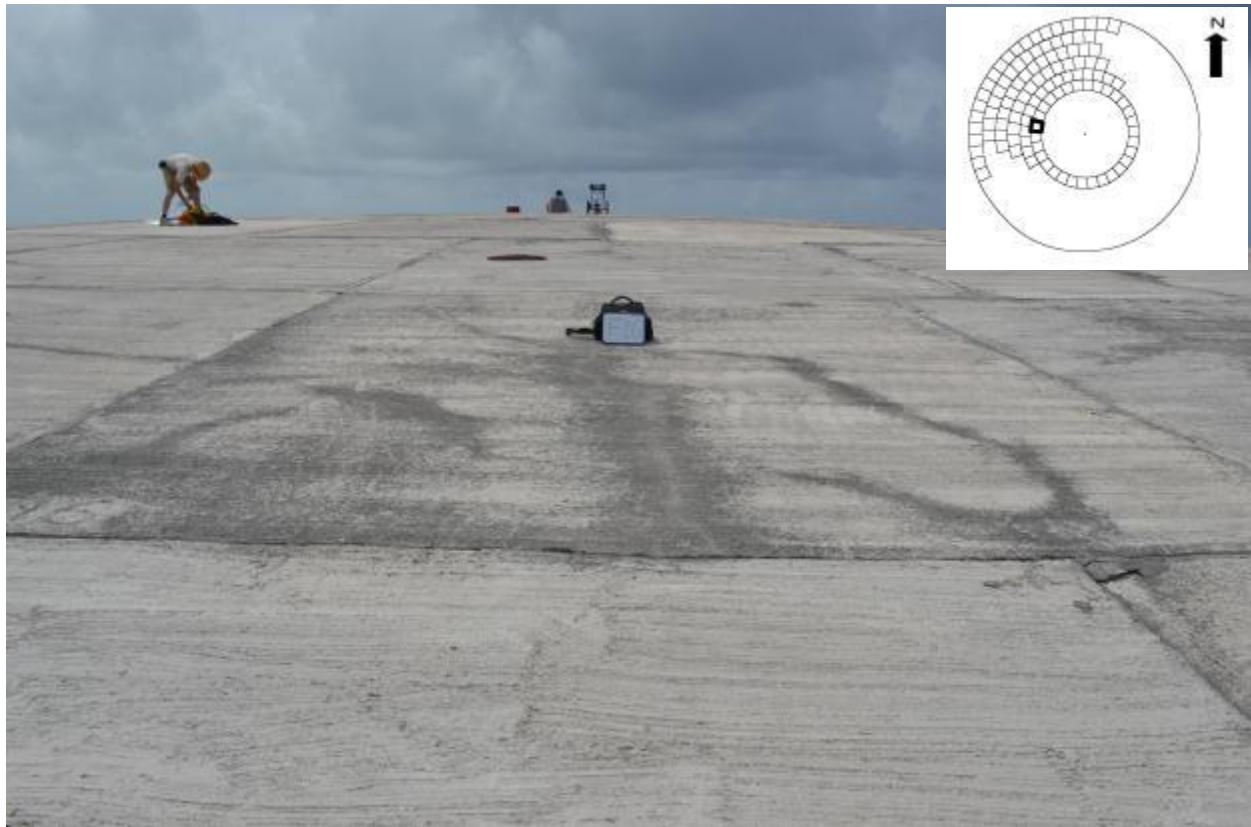
CAP SECTION LOCATION: Panel F16

Rooting vegetation removed from along the panel seams. A surface crack with spalled edges is clearly visible traversing up from the bottom seam from a point adjacent to the corner intersection of the E19/E20 panels on the ring rows below. There is a separate crack traversing up through the middle of the panel from a central position along the bottom seam.

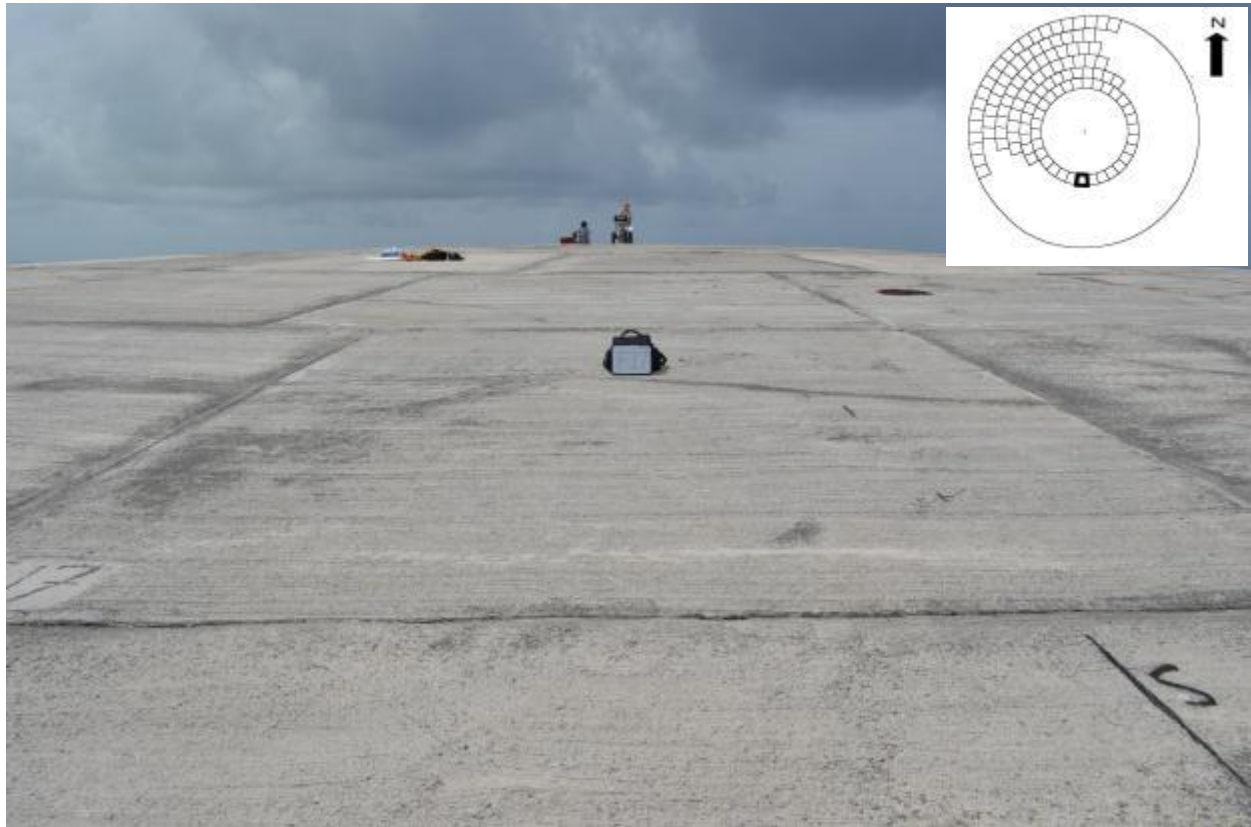
CAP SECTION LOCATION: Panel F17

No significant or obvious interior cracks or spall elements identified. Rooting vegetation removed from along the panel seams. Some minor spalling/chipping of concrete in bottom right-hand corner of the panel.

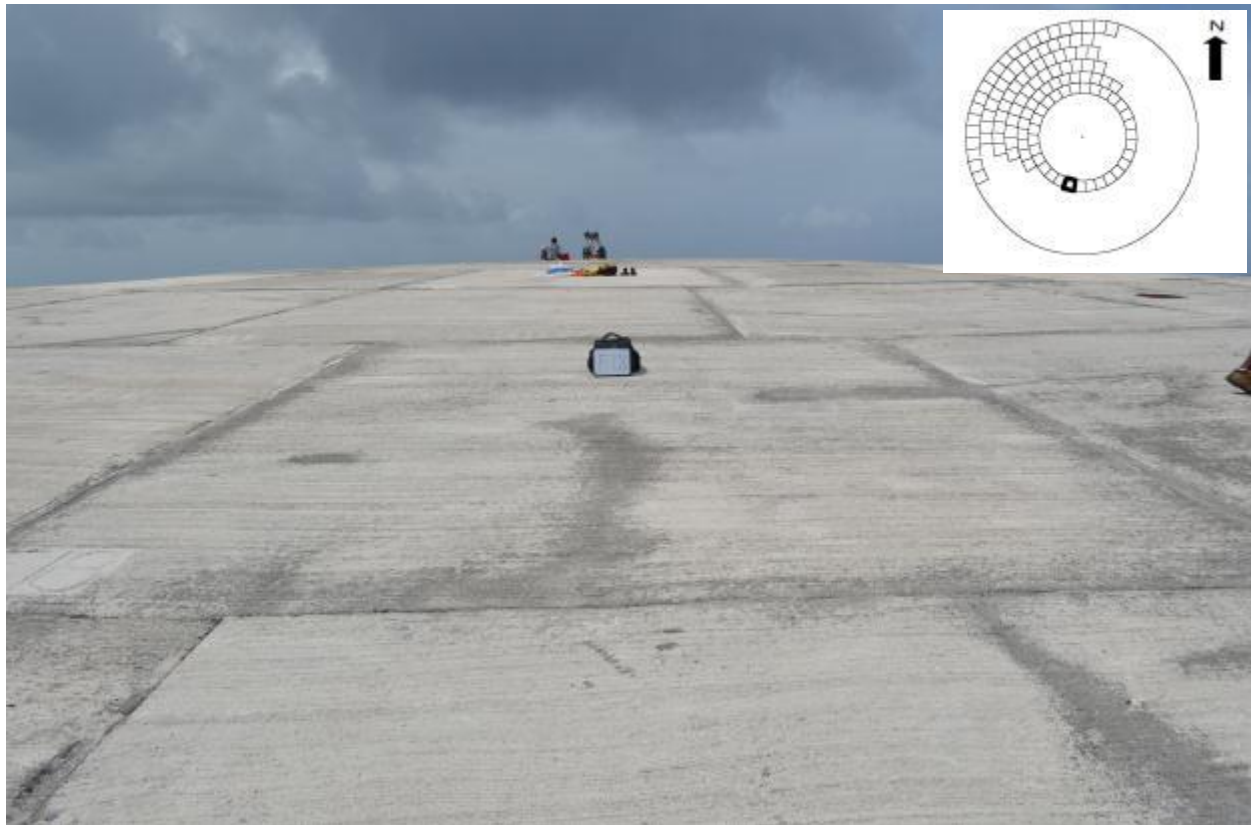
CAP SECTION LOCATION: Panel F18

Rooting vegetation removed from along the panel seams. There is a surface crack traversing up through the middle of the panel from a central position along the bottom seam.

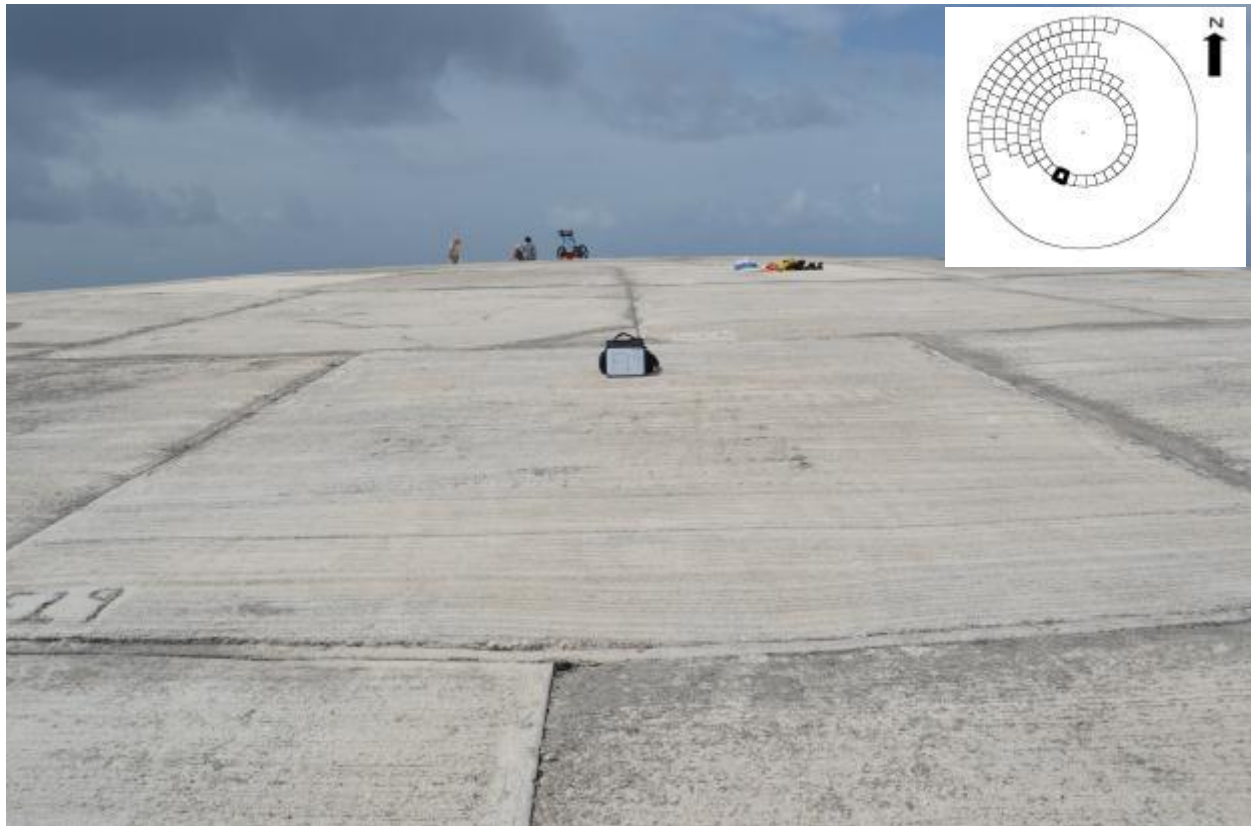
CAP SECTION LOCATION: Panel F19

No significant or obvious interior cracks or spall elements identified.

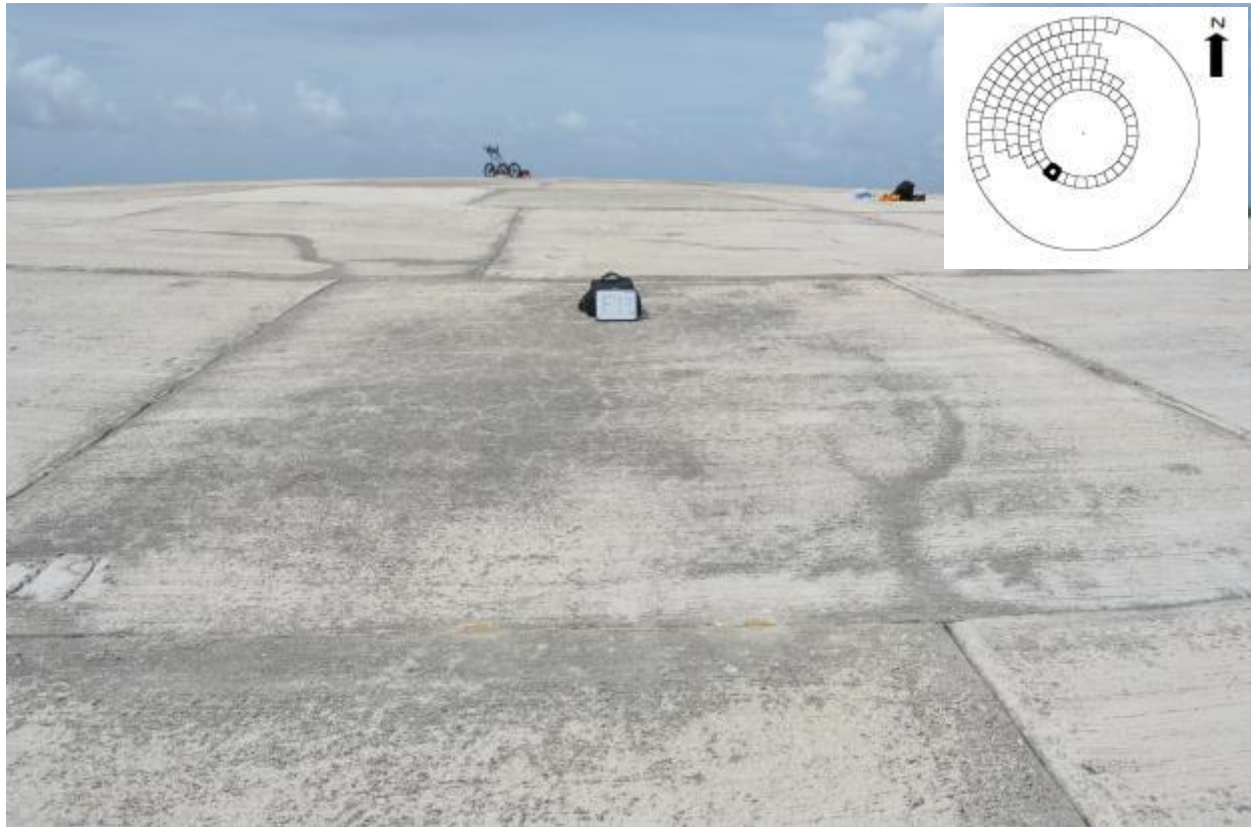
CAP SECTION LOCATION: Panel F19_duplicate (F20)

The panel has a rough and weathered appearance. There is a surface crack traveling up the panel for about 2 meters from a point adjacent to the corner intersection of the E19/E20 panels on the ring rows below.

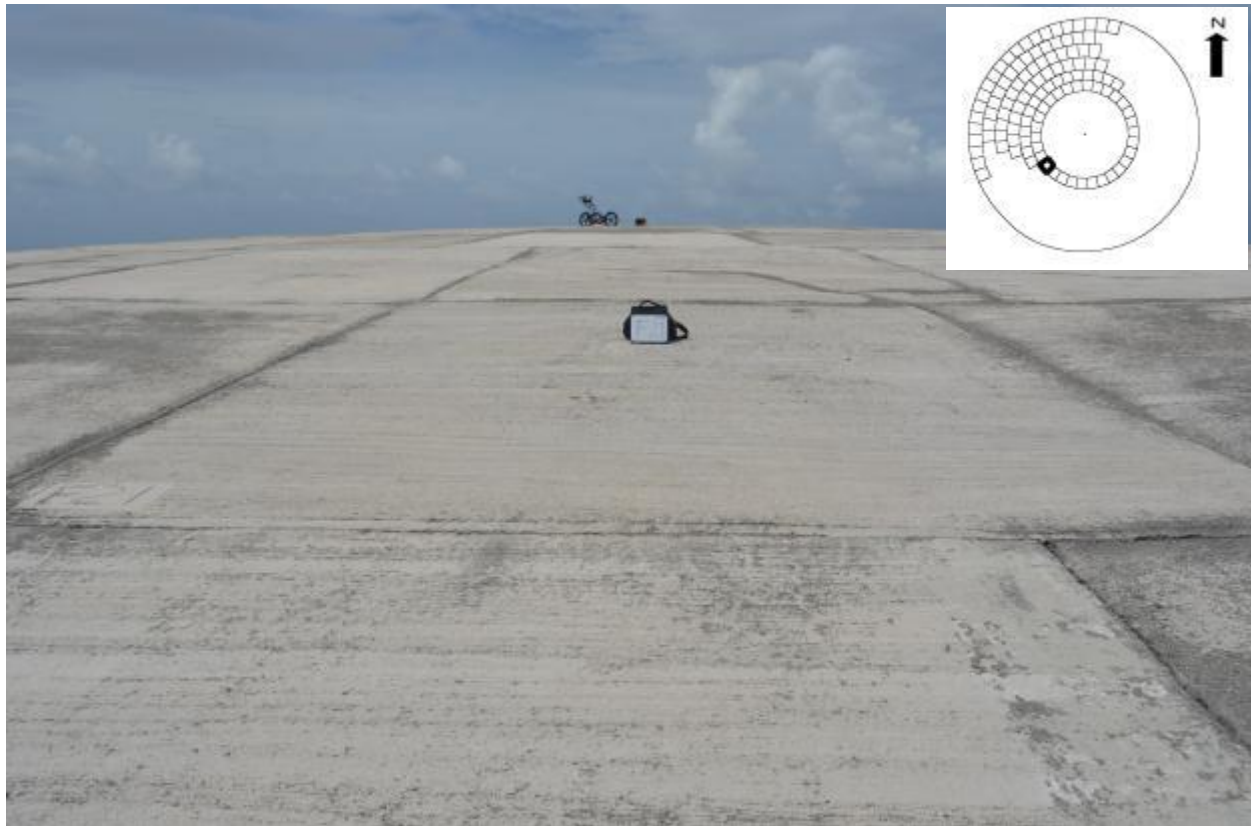
CAP SECTION LOCATION: Panel F21

No significant or obvious interior cracks or spall elements identified.

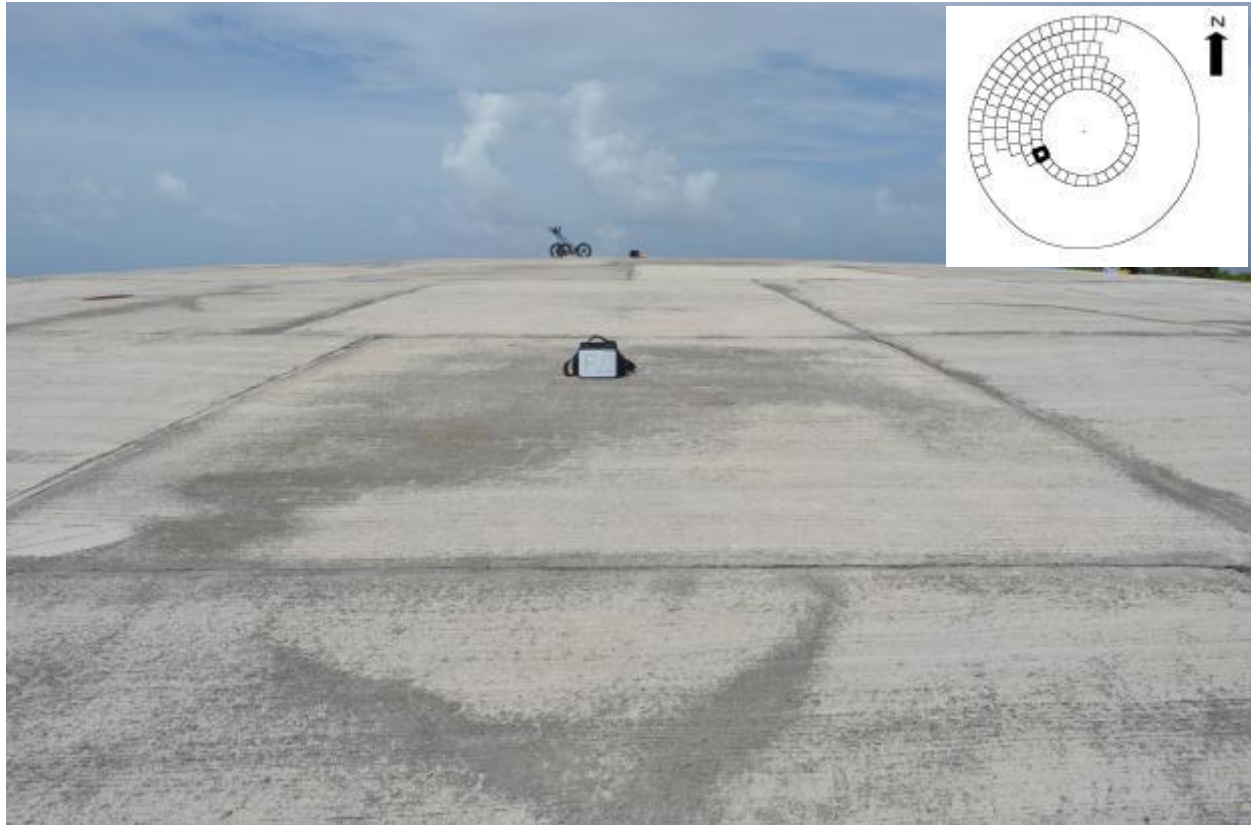
CAP SECTION LOCATION: Panel F22

No significant or obvious interior cracks or spall elements identified. Some minor spalling/chipping of concrete in the upper left-hand corner of the panel.

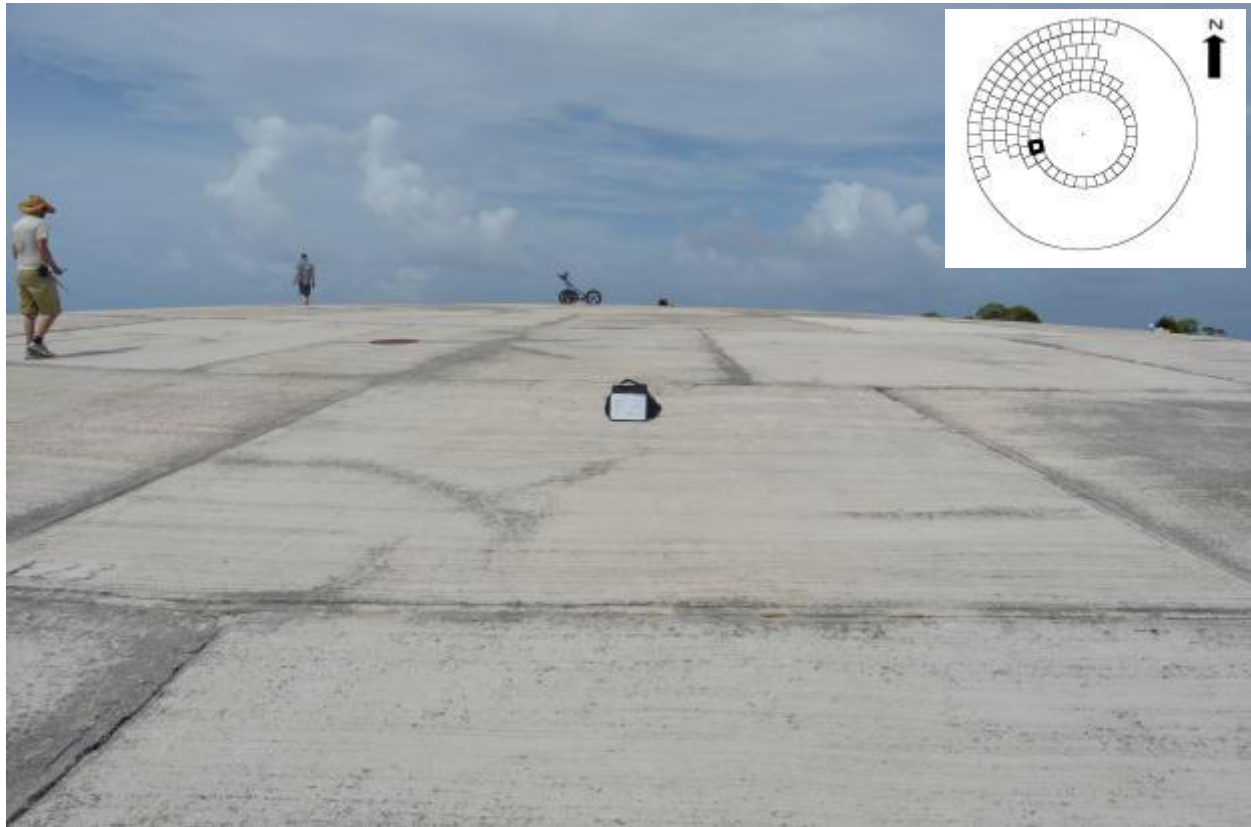
CAP SECTION LOCATION: Panel F23

No significant or obvious interior cracks or spall elements identified.

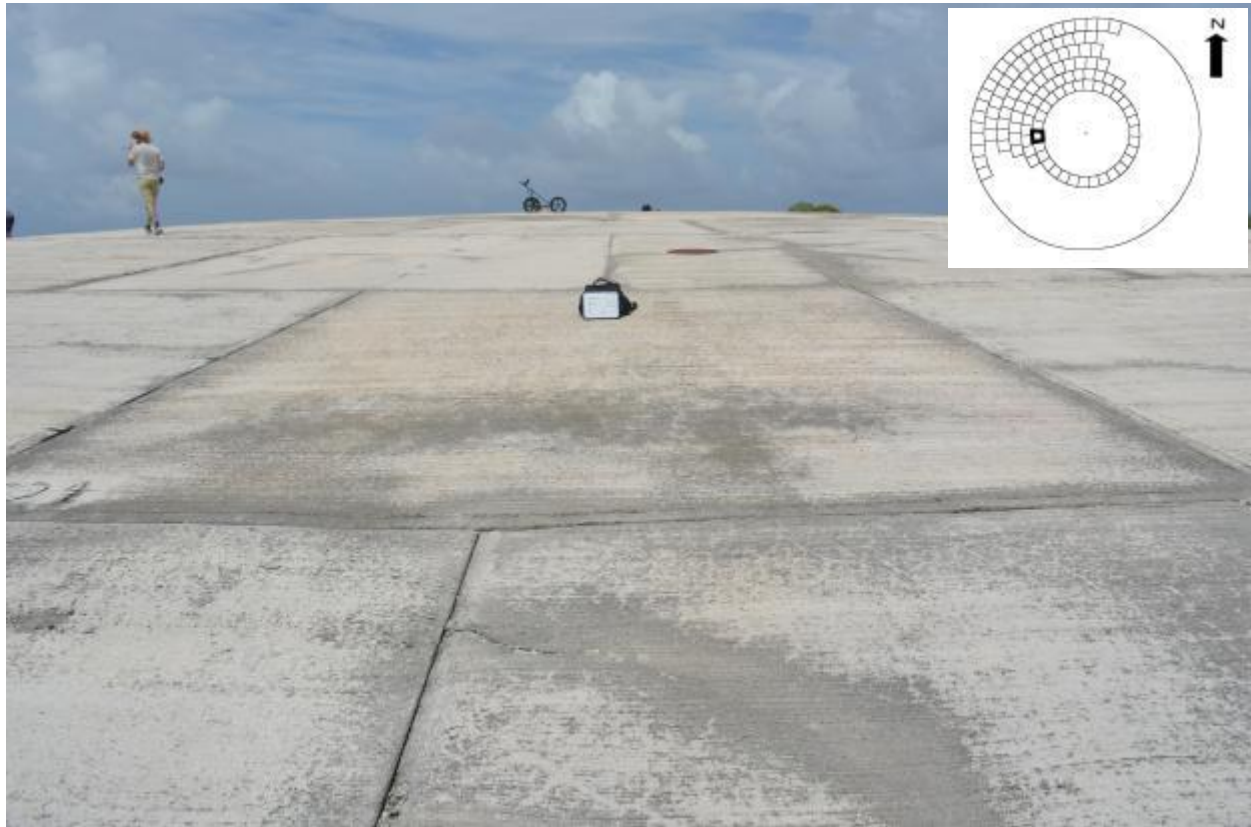
CAP SECTION LOCATION: Panel F24

The panel has a rough and weathered appearance. No significant or obvious interior cracks or spall elements identified. Some spalling/chipping of concrete in the bottom left-hand corner of the panel.

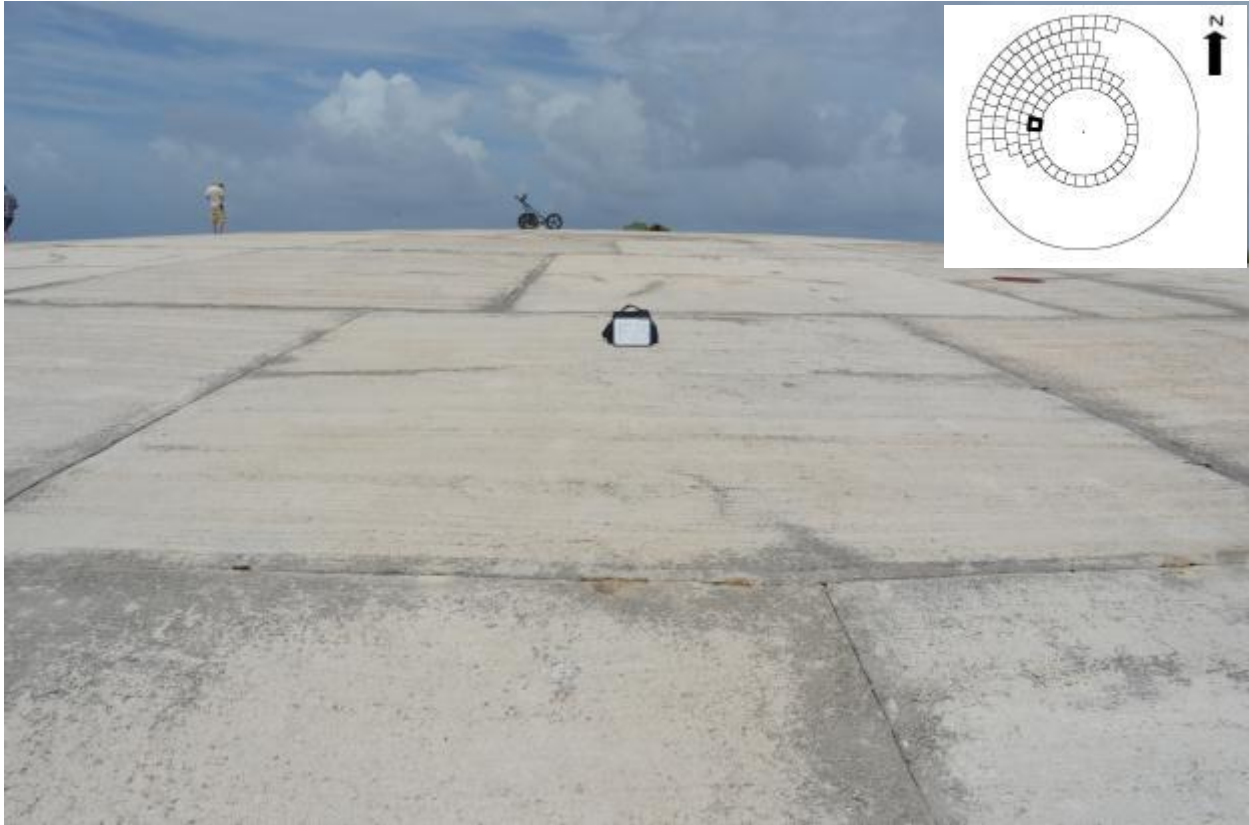
CAP SECTION LOCATION: Panel F25

No significant or obvious interior cracks or spall elements identified. Some spalling/chipping of concrete in the bottom right and left-hand corners of the panel. Rooting vegetation removed from along the panel seams.

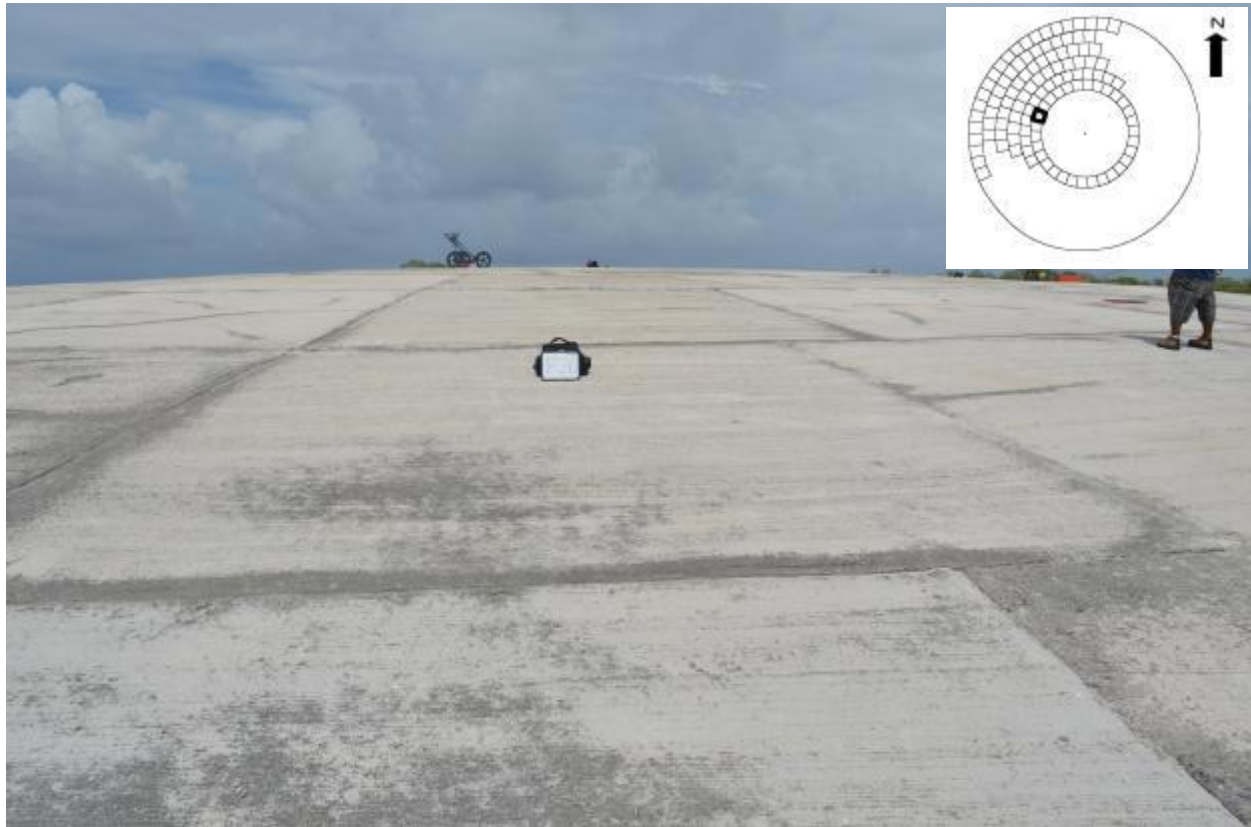
CAP SECTION LOCATION: Panel F26

No significant or obvious interior cracks or spall elements identified. Some spalling/chipping of concrete in the bottom right-hand corner. Rooting vegetation removed from along the panel seams.

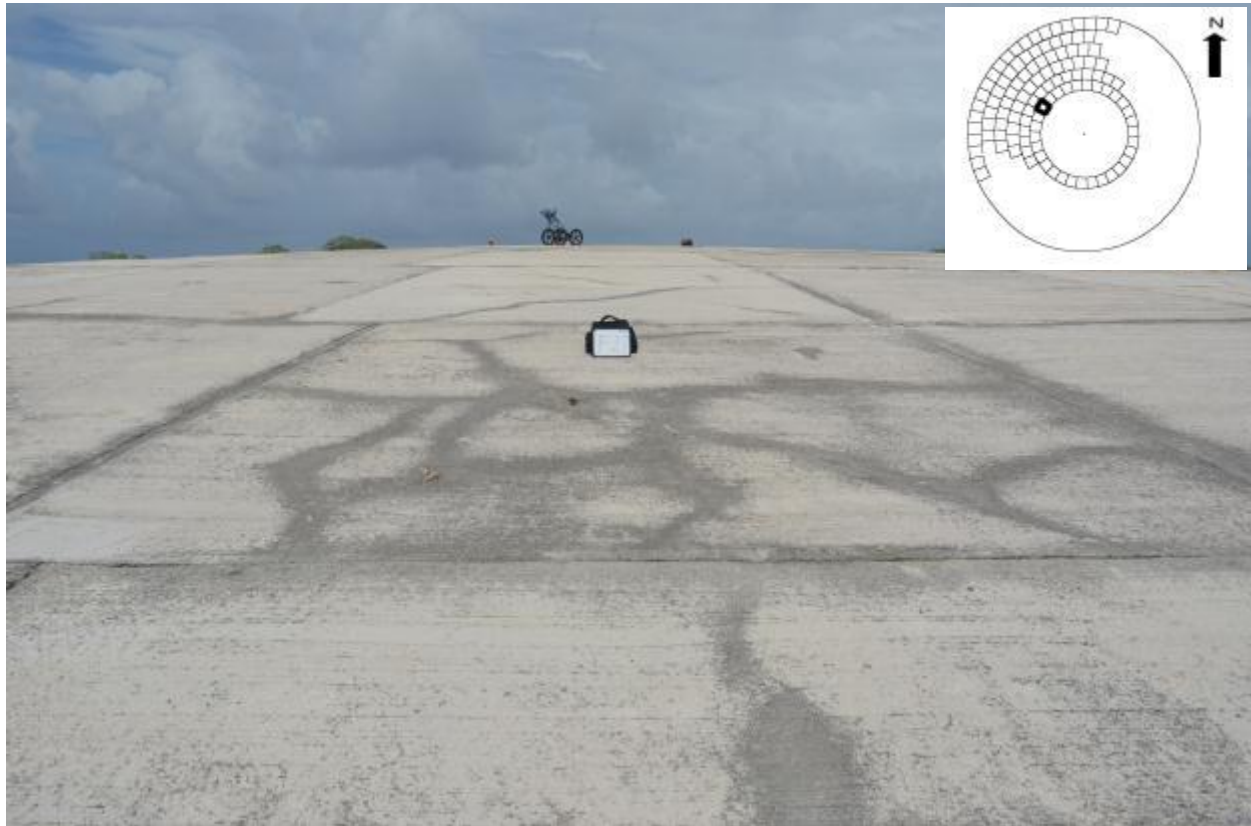
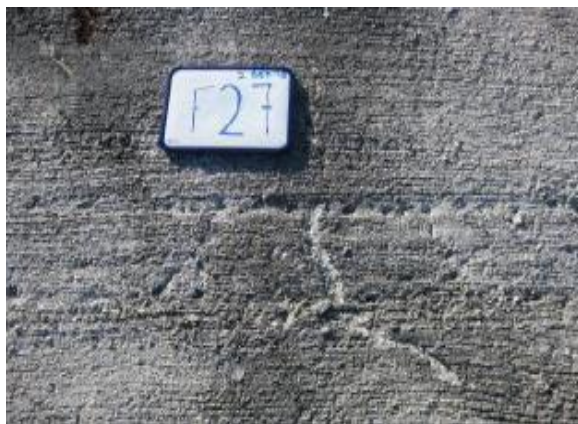
CAP SECTION LOCATION: Panel F27

The panel has a rough and weathered appearance. Multiple surface cracks observed crisscrossing up through the middle of the panel with intersections reaching out to the bottom, top, left and right-hand edges. Some spalling/chipping of concrete along the panel seams.

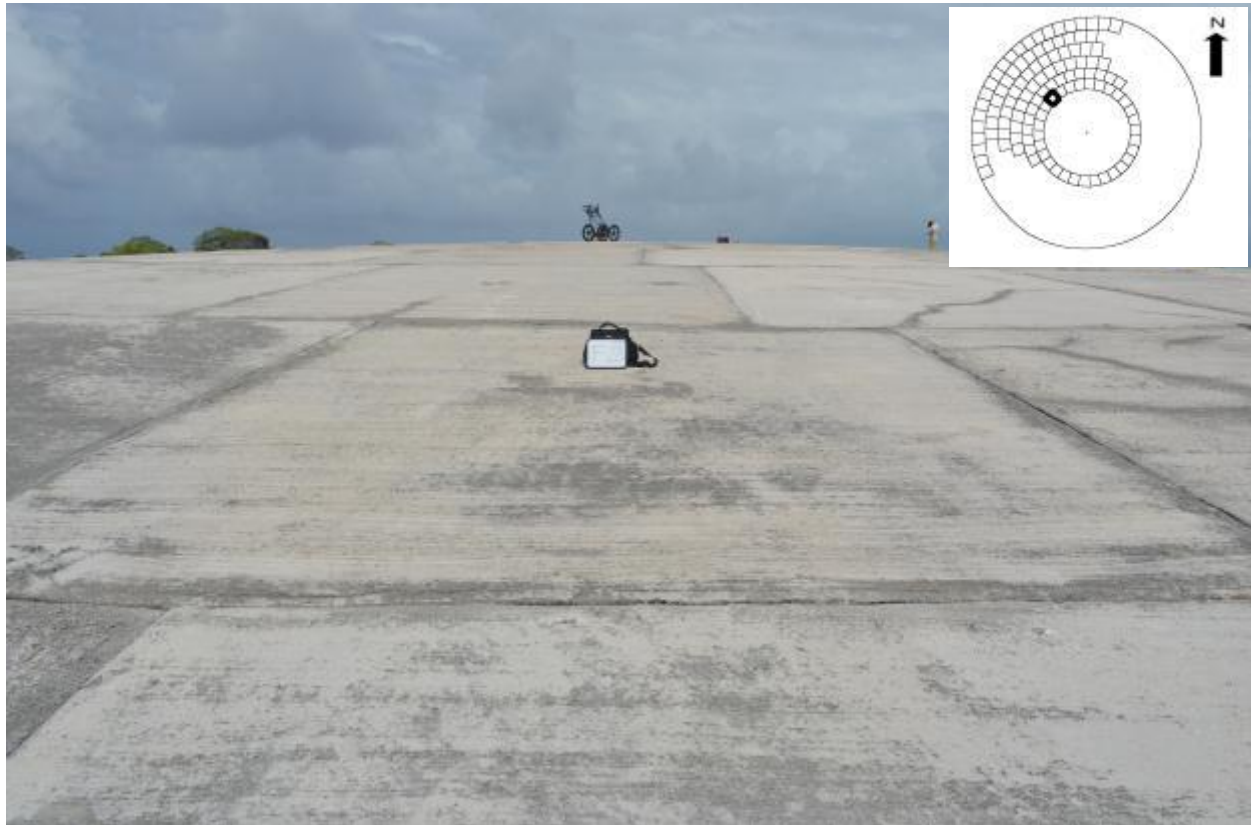
CAP SECTION LOCATION: Panel F28

No significant or obvious interior cracks or spall elements identified. Some spalling/chipping of concrete along the upper right-hand seam of the panel.
